Failure Analysis of ICDP Work Roll of Hot Strip Mill Case Study of Shell-Core Interface Spalling

Keyword: ICDP Work Roll, Hot Strip Mill, Shell-Core Interface, Spalling

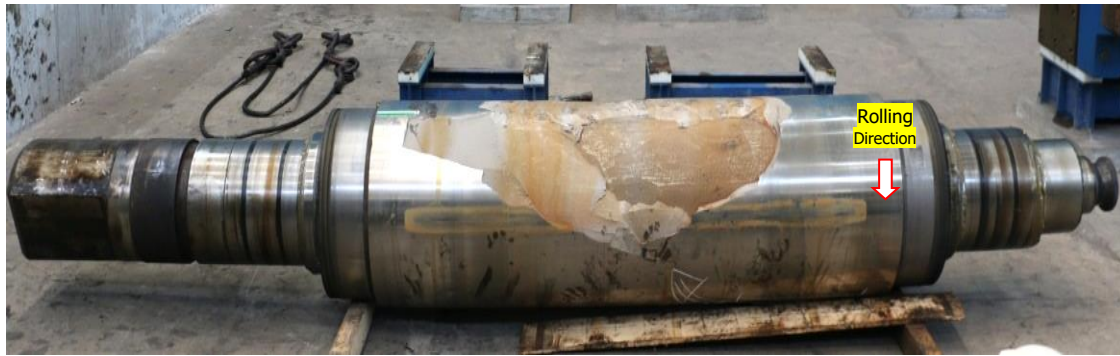
Fig. 2. General view of the spalled roll

Figure 2 shows a general view of the spalled roll. Rolls that have been spalled are subjected to a visual test to identify failure modes. Chemical composition was measured by spectrometer.

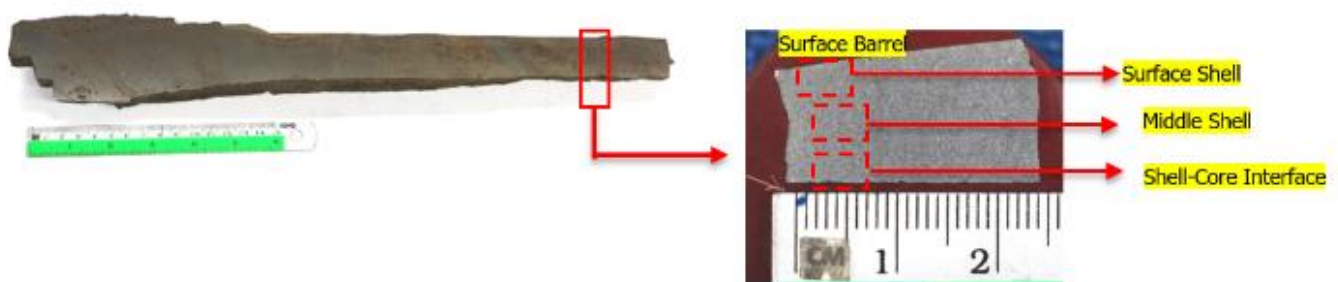
Fig. 3. Specimen for cut analysis

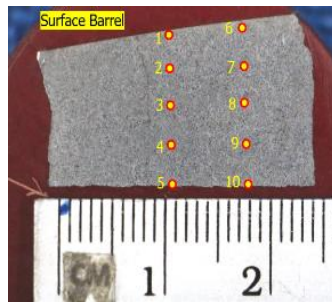
Fig.4. Location of microhardness testing on the spalled sample (shell)

The average hardness value of the shell roll is 725.9 HV.

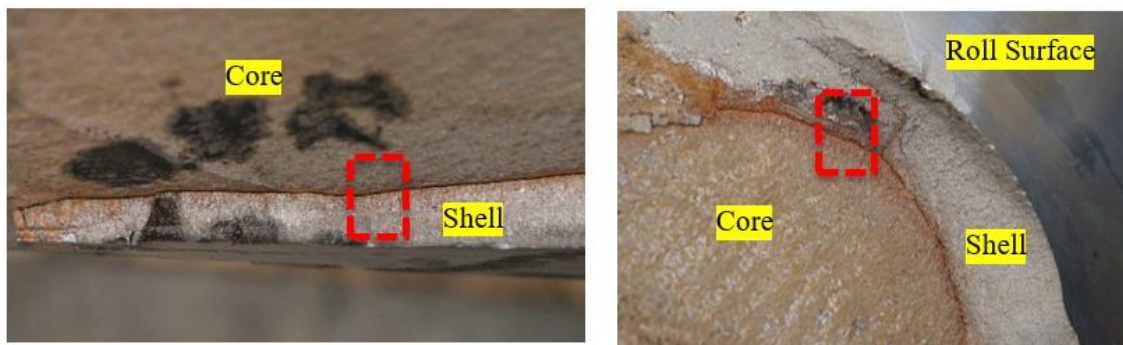
Fig. 5. Detail of spalled roll (shell and core)

From the visual observation in Figure 5, it shows that there was a gap between the shell and the core (the part marked in red). This indicates that the shell and the core bond are not good. The bond between the shell and the core is not good, making it easy for this type of spalling to occur.

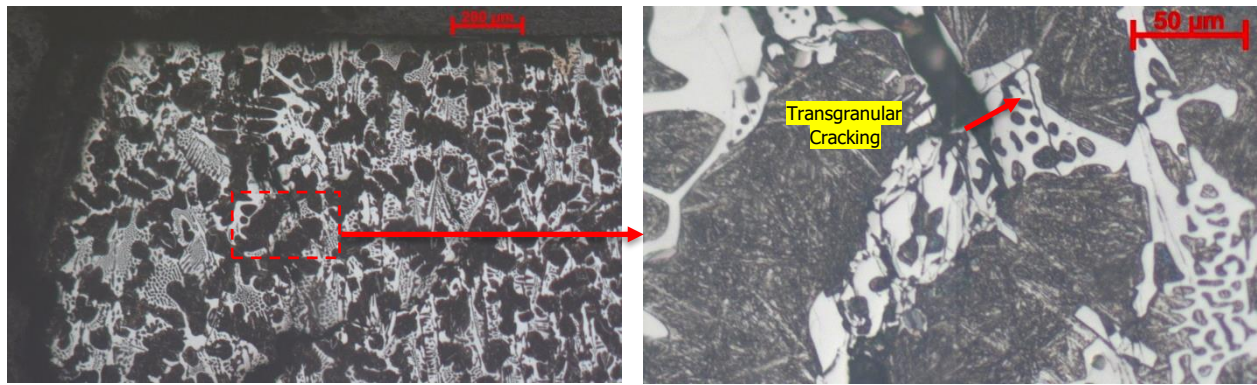
Fig. 6. The microstructure of the spalled sample

Metallography was carried out to examine the microstructure of the roll at the location of spall. Microstructure obtained by SEM with EDS is shown in Fig. 6 and fig 7. The microstructure is a matrix of martensite with graphite.

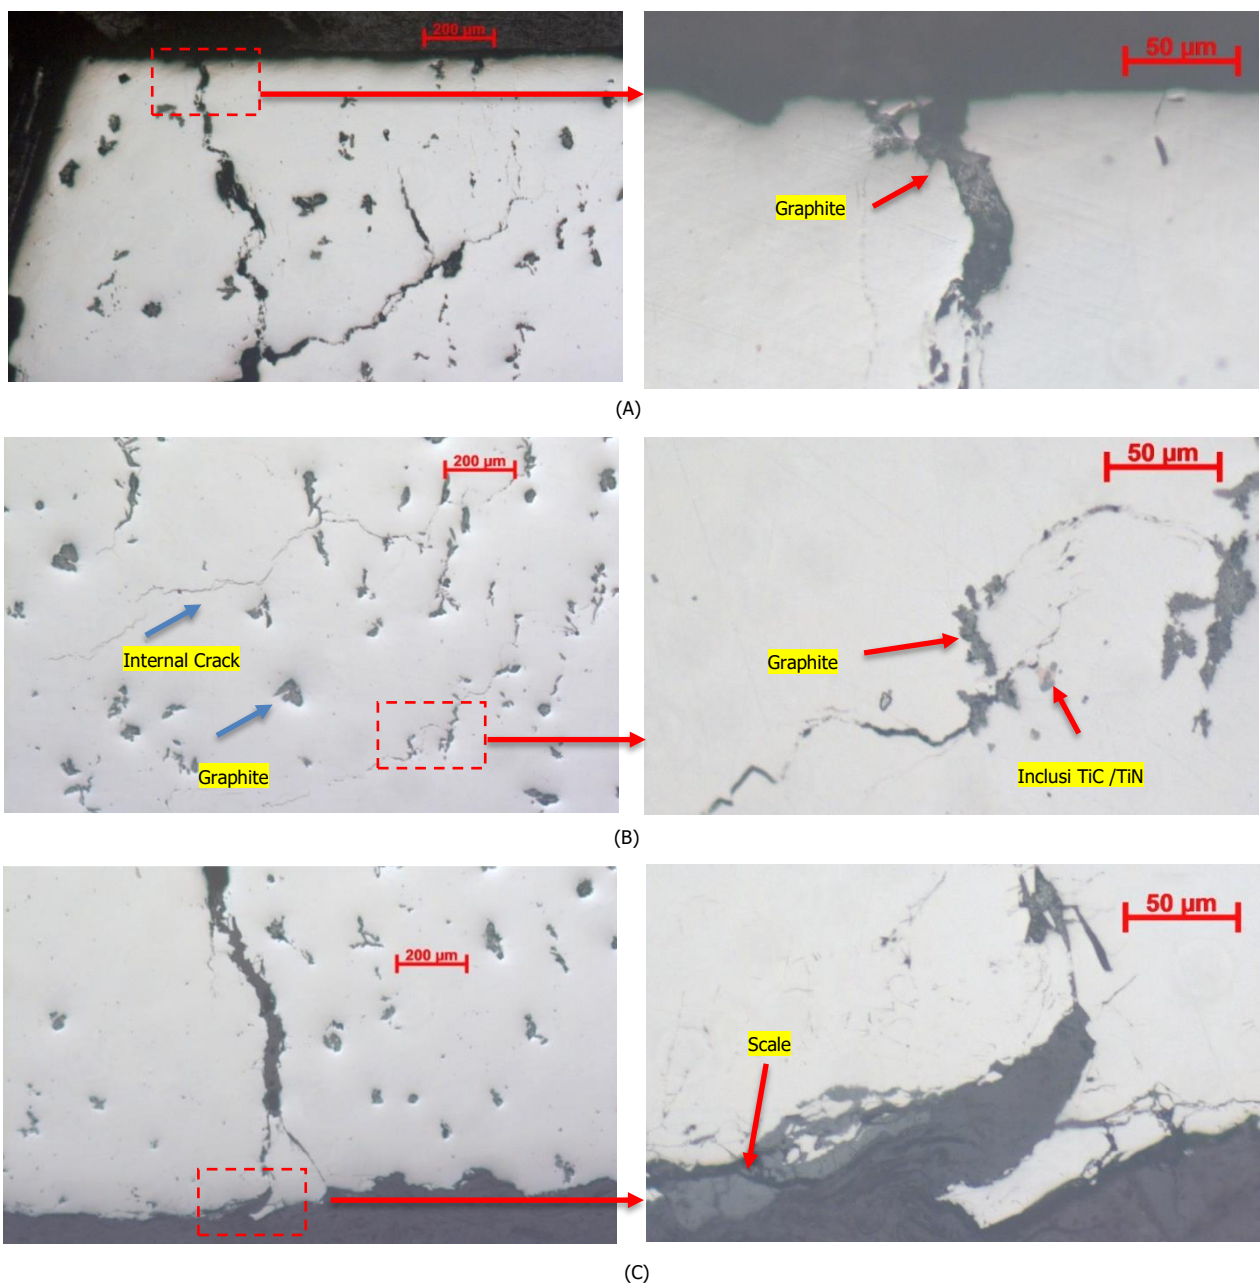
Fig. 7. The microstructure of the cross-section of the shell . (A) at the surface shell, (B) at the middle of shell and (C) at the shell-core interface

The microstructure of the shell samples tested showed a martensitic matrix with the presence of graphite. This microstructure is typical in ICDP rolls. Intergranular cracking in the shell is around the graphite phase. Intergranular cracking initiates crack propagation when a roll spall occurs. Fig 7 shows that the presence of graphite in the ICDP causes deformation and cracking in connection to graphite-rich regions under loading. Graphite phase is beneficial since it may act as a solid lubricant reducing the interfacial friction force in the sliding contact (Nilsson & Olsson, 2013). EDS analysis confirmed the oxide or scale at the shell-core interface.

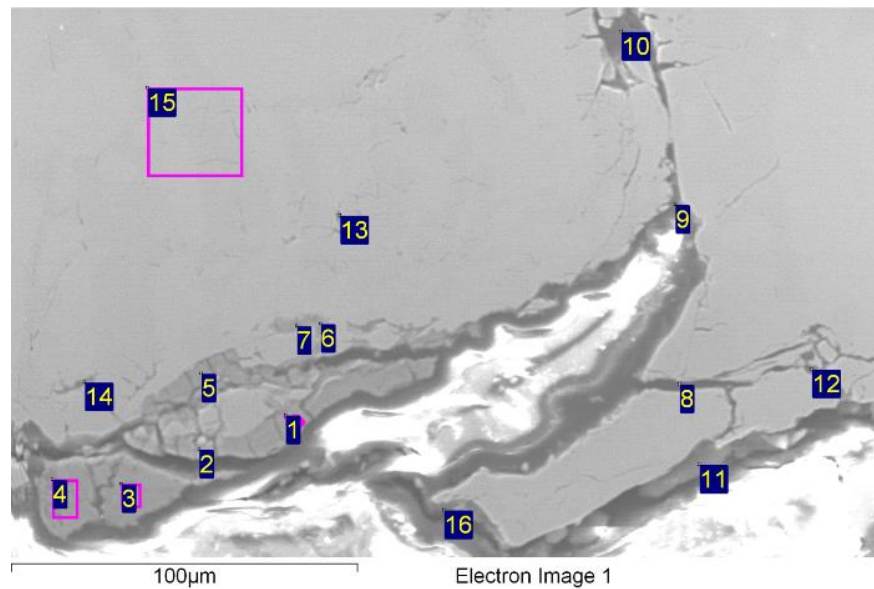
Fig. 8. EDS analysis of spalled sample on the shell – core interface

In the shell, inclusion TiC and TiN and micro cracks were found with the type of transgranular cracking. The results of the EDS test in the Shell-Core interface area were found to be oxide or scale compounds. The results of the EDS test can be seen in table 3.

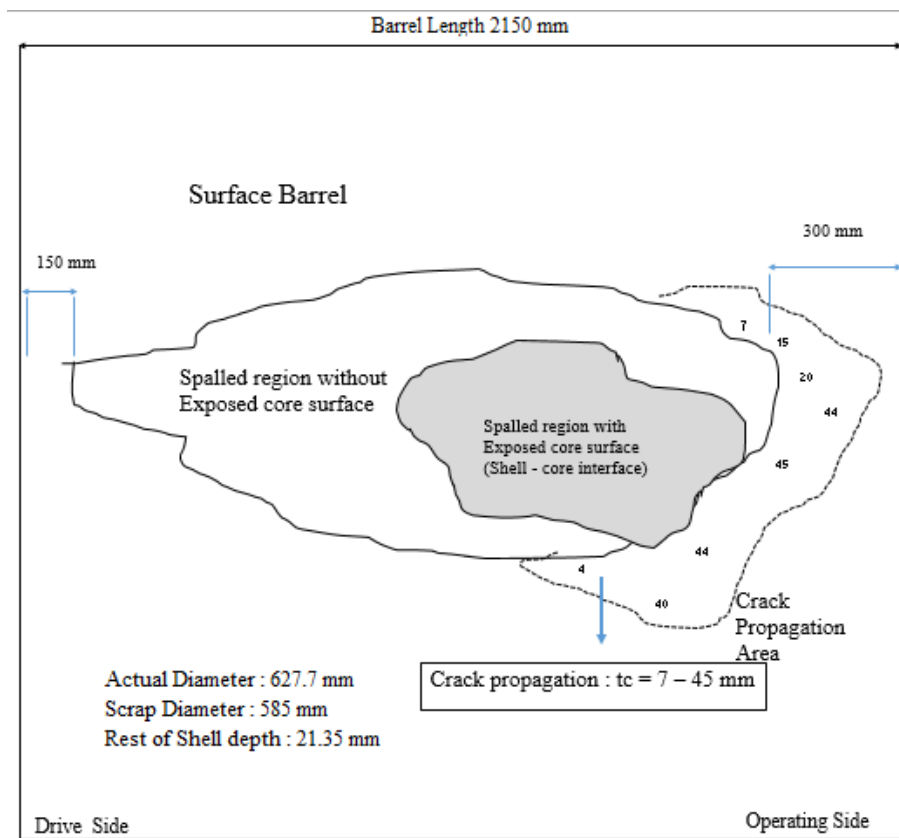
Crack propagation mapping has been measured using an ultrasonic test with the USKS 8S type. UT test parameters are presented in the table 4. The propagation of the crack can be seen in Figure 9. The propagation of the crack is 7-45 mm deep around the non-spalled area on the Operating Side.

Fig. 9. Two-dimensional projection of ultrasonic test results on a spalled roll.

Ultrasonic evaluation of the spalled roll revealed a crack propagation from the exposed spalled region at the operating side. The depth of the crack was 7-45 mm. The propagation crack may be a consequence of spalling.
