Corrosion failure analysis of CuNi 90/10 on seawater fire protection system

Abstract—The failure analysis of a seawater fire protection system of oil and gas processing facility was observed in this paper. The fire protection pipe line & hull seawater filter were made of CuNi 90/10. Severe deep pits and fracture were observed at bottom of jockey pump spool pipe and hull seawater filter. Visual observation, scanning electron microscope, energy dispersive spectroscopy, x-ray diffractometry were employed in the present failure analysis. The oxygen exposure on CuNi 90/10 of Seawater Fire Protection system had a significant impact on failure and was exacerbated by the presence of chloride exposure.

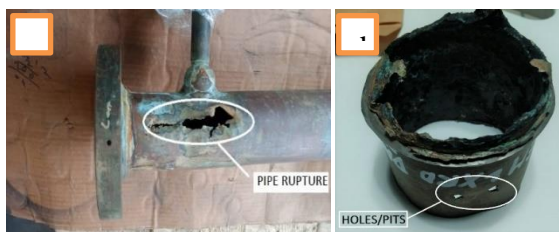
ring with sodium hypochlorite treated seawater to prevent marine growth developing within the distribution network. Figure 1 shows the simple diagram of the fire protection system. The treated seawater analysis of the fire protection system was listed in the Table 1. Figure 2 shows fractures and pits that occur in hull seawater filter and the jockey pump spool pipe of seawater fire protection system. This case keeps happening on this system. Surface treatment has been carried out using Belzona on the inside to reduce the corrosion rate that continues to occur. The chemical composition of Belzona was listed in the Table 2.

Figure 2. Failure at (a) Hull Sea Water Filter, (b) Jockey Pump spool

The pit and fracture occurred in the spool jockey pump fire-protection system were mostly caused by the corrosion phenomenon due to the large amount of oxygen contained in the fluid service (sea water). The presence of chloride content in seawater exacerbates the corrosion process, especially as the cause of pits. Other damage mechanisms such as micro-bacteria, solid particles, flow service, pressure & temperature do not have a large enough impact on the corrosion phenomenon of this system. The composition of the CuNi 90/10 material that does not meet ASTM standards which can reduce corrosion resistance also exacerbates the phenomenon of failure due to corrosion. The presence of Wustite (FeO) can be concluded as an impurity/residual result of the manufacturing process for CuNi 90/10 material. The large composition of carbon compounds on the surface of the material is derived from Belzona.

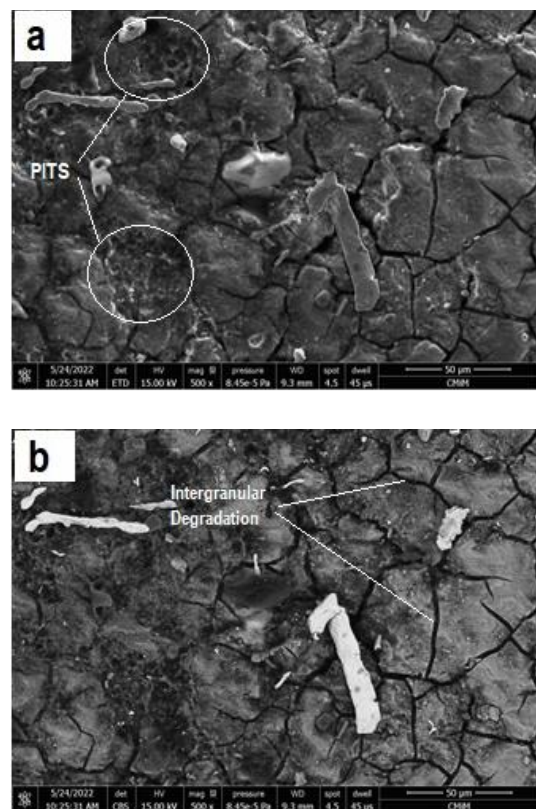
Figure 3. (a) Secondary Electrons (SE) with mag. 500X, (b) Backscattered-Electron (BSE) with mag. 500X of Jockey pump specimen

The topographic and morphological imaging with SEM as shown in Figures 3 and 4. There is a degradation, especially at the grain boundaries (intergranular). The degradation that occurs looks like cracks that spread along the grain boundaries. There are also pits which were marked with black imaging which showed deep topography. Intergranular corrosion is a common characteristic for copper alloy material in seawater environment (Zhu & Lei, 2001). Corrosion occurs starting at the grain boundaries, then continues to spread to the surface to form a layer of copper oxide. At the beginnings, the layer formation was uneven and the adsorption of Cl^- ions was also inconsistent. Nickel corrosion occurs on the pipe surface causing decreased surface protection in some areas. The Cu_2O film is divided into an inner layer and an outer layer, where the outer layer is produced by the deposition of dissolved Cu^{2+} while the inner layer is produced by a more compact and protective Cu_2O film. The grain boundaries or other defects in the Cu matrix are below the corrosion product film. The growth rate of the corrosion product film in this area is slower than in the intergranular due to differences in structure and composition. When the corrosion time is extended, oxidation products in the outer layer are formed on the surface and the content is gradually increased. However, the strength of the corrosion product film is lower than its internal stress, so the product is porous and easy to fall off which causes cracks in the film (Jin et al., 2019). Cracks that occur at grain boundaries will damage the passive layer and cause pitting initiation (Kong et al., 2018).

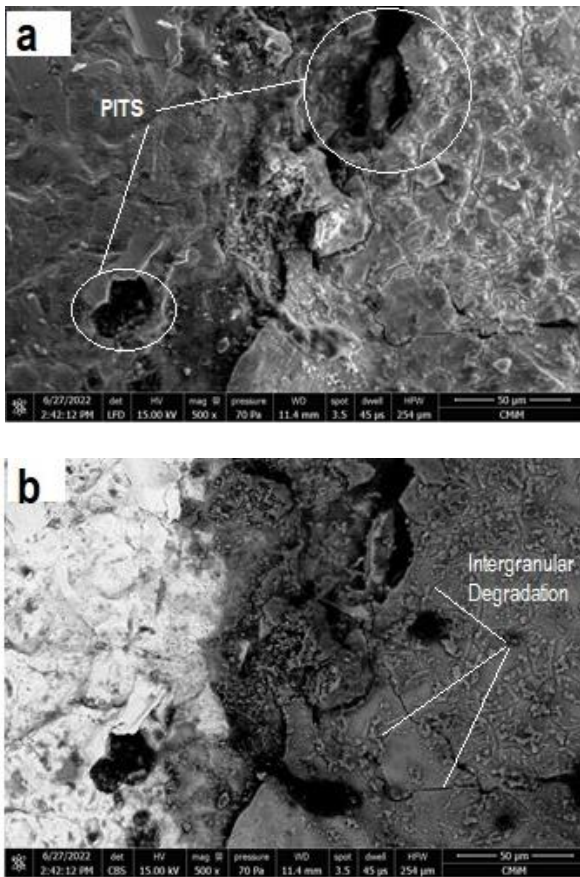
Figure 4. (a) Secondary Electrons (SE) with mag. 500X, (b) Backscattered-Electron (BSE) with mag. 500X of Hull Sea Water Filter Specimen

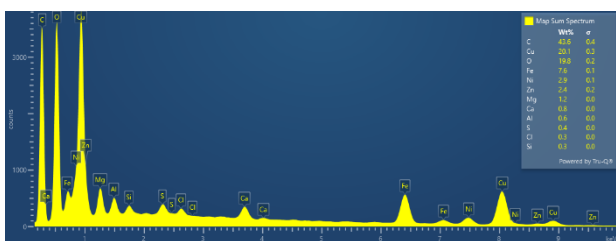
Referring to EDS results shown in Figures 5 and 6 seen that several compounds which trigger damage due to corrosion, both general and local, including oxygen and chloride. The specimen surface has significantly higher degree of both oxygen & chloride enrichment. CuNi has excellent corrosion resistance in seawater environments. Besides Cu has a high potential value (so that the oxidation process is difficult). The presence of Nickel can also increase the resistance of the Cu_2O passive layer formed on CuNi metal. The corrosion process on CuNi can occur due to the presence of Chloride ions and large dissolved oxygen. Although the reaction of Cu and Oxygen can form a passive layer, the presence of a lot of oxygen can trigger oxidation because the electrode potential of Cu is

Sulphur compounds that are read on the EDS results are relatively very small around 0.4% for Jockey pump and 0.6% for Hull Sea water filter specimen, see Figures 5 and 6. In addition, since copper alloys are good biofouling inhibitors (Drach et al., 2013), this is also supported by the quality of seawater that been treated to reduce microbes in the fire protection system, which is indicated by the low results of SRB check in water analysis reports, see Table 1. SRB may be formed due to under deposit corrosion carried by seawater at small or stagnant fluid velocity (below 1 m/s). On the other hand, in case of copper alloys, it has been generally recognized that increasing flow velocities have no significant effect on the corrosion rate until a critical velocity so called breakaway velocity is reached. The maximum fluid velocity in CuNi 90/10 systems are known to be limited to 3.5 m/s (Schleich, 2004). Based on Table 1, the seawater fluid velocity of the fire protection system is within the recommended range. where the lower limit of the fluid velocity (below 1 m/s) can allow deposits to occur and the upper limit of the fluid velocity (3.5 m/s) which can allow corrosion-erosion to occur.

Figure 5. EDS Spectrum of jockey pump specimen

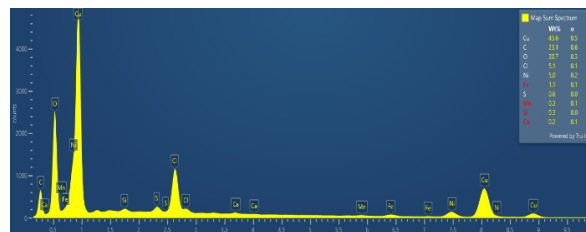
Figure 6. EDS Spectrum of hull Sea Water filter specimen
