Corrosion Failure Analysis of CuNi 90/10 on Seawater Fire Protection System

Abstract—The failure analysis of a seawater fire protection system of oil and gas processing facility was observed in this paper. The fire protection pipe line & hull seawater filter were made of CuNi 90/10. Severe deep pits and fracture were observed at bottom of jockey pump spool pipe and hull seawater filter. Visual observation, scanning electron microscope, energy dispersive spectroscopy, x-ray diffractometry were employed in the present failure analysis. The oxygen exposure on CuNi 90/10 of Seawater Fire Protection system had a significant impact on failure and was exacerbated by the presence of chloride exposure.

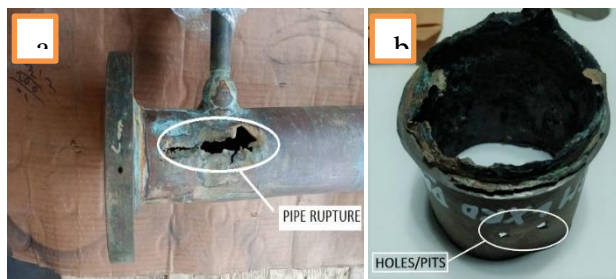
growth developing within the distribution network. Figure 1 shows the simple diagram of the fire protection system. The treated seawater analysis of the fire protection system was listed in the Table 1. Figure 2 shows fractures and pits that occur in hull seawater filter and the jockey pump spool pipe of seawater fire protection system. This case keeps happening on this system. Surface treatment has been carried out using Belzona on the inside to reduce the corrosion rate that continues to occur. The chemical composition of Belzona was listed in the Table 2.

Figure 2. Failure at (a) Hull Sea Water Filter, (b) Jockey Pump spool

dissolved oxygen, the red-black passive layer breaks down and causes the pit to deepen. Corrosion products and a greenish layer often form when corrosion is serious and ongoing (Jin et al., 2019; Subai et al., 2014) as seen in Figure 2. Copper reacts with oxygen to form a passive layer of CuO or Cu_2O with nickel as a stabilizer of the layer. It is common, the corrosion layer of Cu/Ni 90-10 is characterized by the significantly higher degree of iron enrichment resulting in the increased depletion of copper (Drach et al., 2013). This is in line with the results of the EDS analysis where there is a reduction in the composition of copper & nickel but on the contrary, there is an increase in the composition of Fe.

The pit and fracture occurred in the spool jockey pump fire-protection system were mostly caused by the corrosion phenomenon due to the large amount of oxygen contained in the fluid service (sea water). The presence of chloride content in seawater exacerbates the corrosion process, especially as the cause of pits. Other damage mechanisms such as micro-bacteria, solid particles, flow service, pressure & temperature do not have a large enough impact on the corrosion phenomenon of this system.

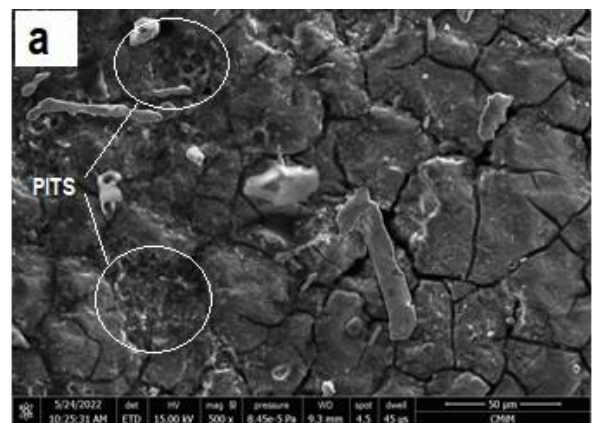
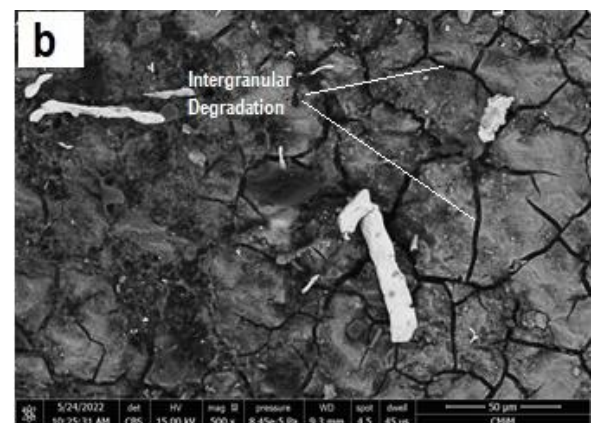
Figure 3. (a) Secondary Electrons (SE) with mag. 500X, (b) Backscattered-Electron (BSE) with mag. 500X of Jockey pump specimen

The topographic and morphological imaging with SEM as shown in Figures 3 and 4. There is a degradation, especially at the grain boundaries (intergranular). The degradation that occurs looks like cracks that spread along the grain boundaries. There are also pits which were marked with black imaging which showed deep topography. Intergranular corrosion is a common characteristic for copper alloy material in seawater environment (Zhu & Lei, 2001). Corrosion occurs starting at the grain boundaries, then continues to spread to the

surface to form a layer of copper oxide. At the beginnings, the layer formation was uneven and the adsorption of Cl^- ions was also inconsistent. Nickel corrosion occurs on the pipe surface causing decreased surface protection in some areas. The Cu_2O film is divided into an inner layer and an outer layer, where the outer layer is produced by the deposition of dissolved Cu^{2+} while the inner layer is produced by a more compact and protective Cu_2O film. The grain boundaries or other defects in the Cu matrix are below the corrosion product film. The growth rate of the corrosion product film in this area is slower than in the intergranular due to differences in structure and composition. When the corrosion time is extended, oxidation products in the outer layer are formed on the surface and the content is gradually increased. However, the strength of the corrosion product film is lower than its internal stress, so the product is porous and easy to fall off which causes cracks in the film (Jin et al., 2019). Cracks that occur at grain boundaries will damage the passive layer and cause pitting initiation (Kong et al., 2018).

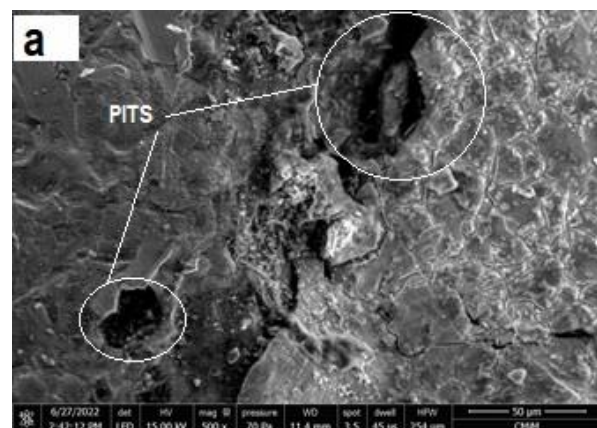
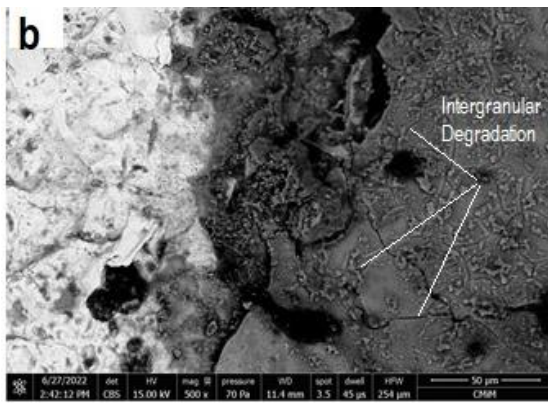
Figure 4. (a) Secondary Electrons (SE) with mag. 500X, (b) Backscattered-Electron (BSE) with mag. 500X of Hull Sea Water Filter Specimen

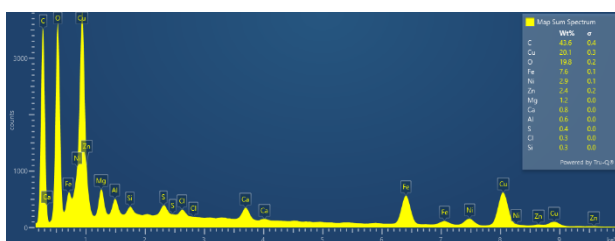
Referring to EDS results shown in Figures 5 and 6 seen that several compounds which trigger damage due to corrosion, both general and local, including oxygen and chloride. The specimen surface has significantly higher degree of both oxygen & chloride enrichment. CuNi has excellent corrosion resistance in seawater environments. Besides Cu has a high potential value (so that the oxidation process is difficult). The presence of Nickel can also increase the resistance of the Cu_2O passive layer formed on CuNi metal. The corrosion process on CuNi can occur due to the presence of Chloride ions and large dissolved oxygen. Although the reaction of Cu and Oxygen can form a passive layer, the presence of a lot of oxygen can trigger oxidation because the electrode potential of Cu is more negative when compared to oxygen. The presence of Cl ions can exacerbate the situation by damaging the Cu_2O passive layer. Corrosion by dissolved oxygen occurs early on CuNi metal in the seawater environment by forming CuO, Cu_2O . Furthermore, the corrosion process continues with the formation of pitting since the dissolved oxygen in the system accelerated the pitting corrosion of the pipe. Corrosion products on CuNi generally have many layers. The inner layer is evenly brick red and sometimes turns black due to the superposition of the red and black layers. The passive layer on CuNi with the naked eye looks brownish yellow. In the presence of Cl ions and

Sulphur compounds that are read on the EDS results are relatively very small around 0.4% for Jockey pump and 0.6% for Hull Sea water filter specimen, see Figures 5 and 6. In addition, since copper alloys are good biofouling inhibitors (Drach et al., 2013), this is also supported by the quality of seawater that been treated to reduce microbes in the fire protection system, which is indicated by the low results of SRB check in water analysis reports, see Table 1. SRB may be formed due to under deposit corrosion carried by seawater at small or stagnant fluid velocity (below 1 m/s). On the other hand, in case of copper alloys, it has been generally recognized that increasing flow velocities have no significant effect on the corrosion rate until a critical velocity so called breakaway velocity is reached. The maximum fluid velocity in CuNi 90/10 systems are known to be limited to 3.5 m/s (Schleich, 2004). Based on Table 1, the seawater fluid velocity of the fire protection system is within the recommended range. where the lower limit of the fluid velocity (below 1 m/s) can allow deposits to occur and the upper limit of the fluid velocity (3.5 m/s) which can allow corrosion-erosion to occur.

Figure 5. EDS Spectrum of jockey pump specimen

The carbon compounds detected in the EDS test have a very large mass composition in both specimens (jockey pump and hull sea water filter). The composition of carbon compounds may be very small or even absent both in the composition of the material and in the service fluid (sea water). The large carbon compounds that can be read on the EDS is probably a compound of Belzona. As in Table 2, 2 of the 3 main compositions of Belzona (Bisphenol A-(Epichlorhydrin) & Epoxy Phenol Novolac Resin) are organic compounds (carbon bonds).

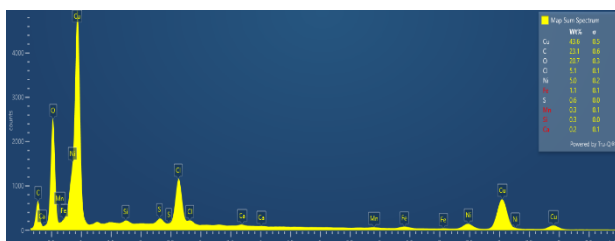
Figure 6. EDS Spectrum of hull Sea Water filter specimen
