## Failure analysis of ICDP work roll of hot strip mill case study of shell-core interface spalling

**Keyword:** *ICDP Work Roll, Hot Strip Mill, Shell-Core Interface, Spalling*

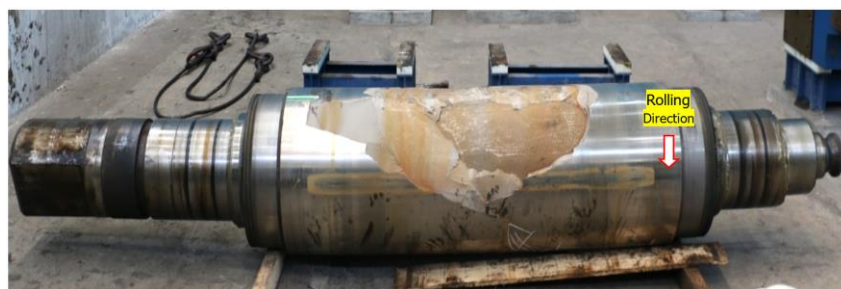
Figure 2 shows a general view of the spalled roll. Rolls that have been spalled are subjected to a visual test to identify failure modes. Chemical composition was measured by spectrometer. A specimen from the roll spall was cut for metallography analysis, as shown in Figure 3. The specimens were mounted with resin and then ground using a grinding machine and polished to 3 microns using standard metallographic techniques. The polished specimens were etched with 2% Nital solution to reveal the microstructures.

Figure 2. General view of the spalled roll

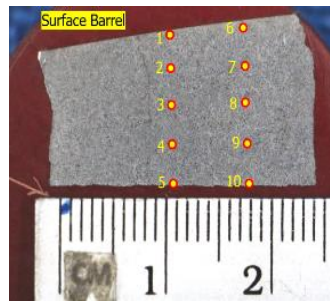
Figure.4. Location of microhardness testing on the spalled sample (shell)

The average hardness value of the shell roll is 725.9 HV.

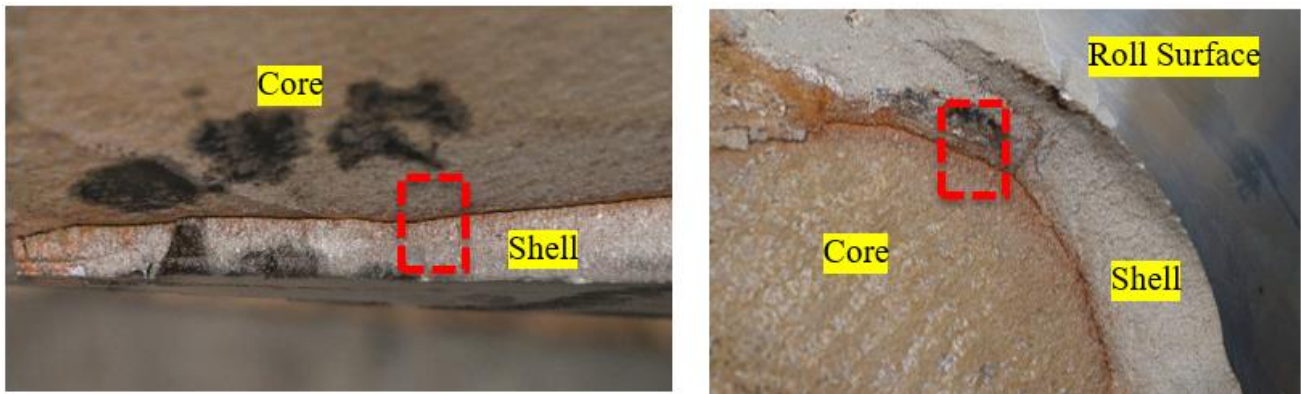
Figure 5. Detail of spalled roll (shell and core)

From the visual observation in Figure 5, it shows that there was a gap between the shell and the core (the part marked in red). This indicates that the shell and the core bond are not good. The bond between the shell and the core is not good, making it easy for this type of spalling to occur. Chemical analysis of the samples was carried out using an Optical Emission Spectrometer (OES) (Model: ARL 4460). The results of the chemical analysis obtained are in Table 1. The samples were tested for hardness using a micro hardness vicker. The results of the hardness test are shown in the Table 2.

Combining all the observations, it can be inferred that the roll spalled because of the influence of the quality of the roll. Where the weak bond between the shell and core causes spalling on the roll so that failures in the mill due to spalled rolls are not repeated, make sure the roll quality from the manufacturer is good, mainly from the strength of bonding between the shell and the core. Make sure that before the new roll is used, the NDT ultrasonic test is carried out to see if there are abnormalities in the roll. used, the NDT.

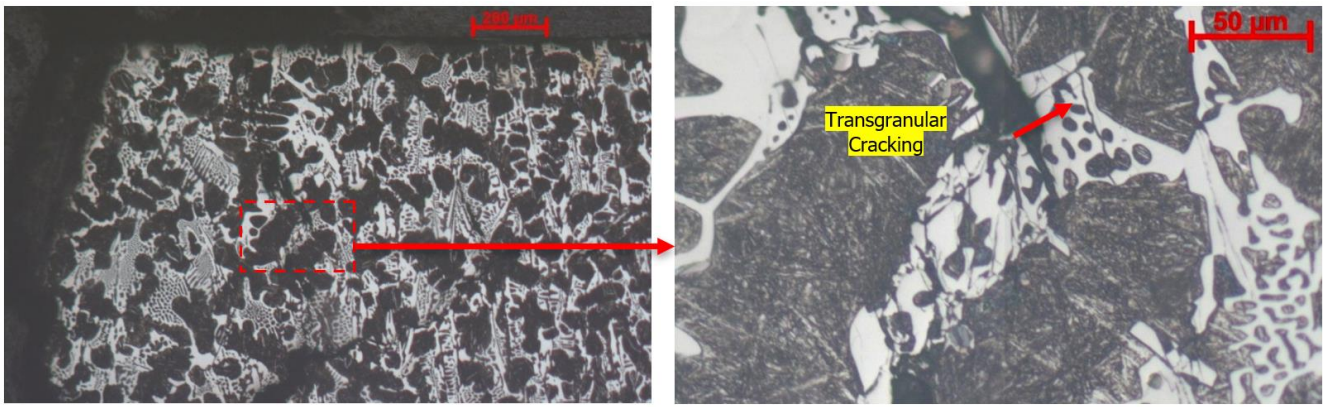
Figure 6. The microstructure of the spalled sample

Metallography was carried out to examine the microstructure of the roll at the location of spall. Microstructure obtained by SEM with EDS is shown in Fig. 6 and fig 7. The microstructure is a matrix of martensite with graphite. In the shell, inclusion TiC and TiN and micro cracks were found with the type of transgranular cracking. The results of the EDS test in the Shell-Core interface area were found to be oxide or scale compounds. The results of the EDS test can be seen in table 3 Crack propagation mapping has

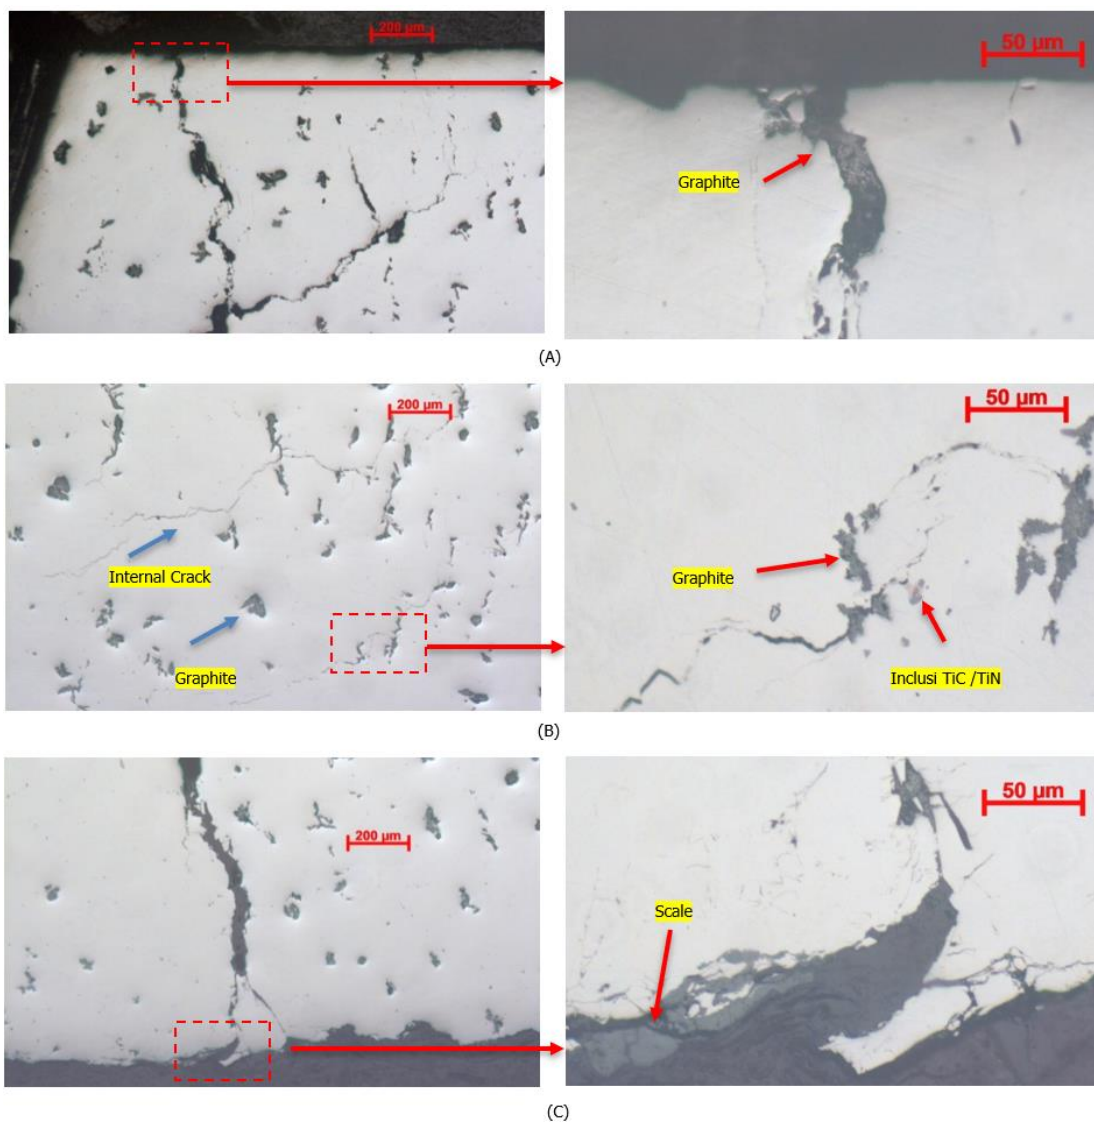
Figure 7. The microstructure of the cross-section of the shell . (A) at the surface shell, (B) at the middle of shell and (C) at the shell-core interface

The microstructure of the shell samples tested showed a martensitic matrix with the presence of graphite. This microstructure is typical in ICDP rolls. Intergranular cracking in the shell is around the graphite phase. Intergranular cracking initiates crack propagation when a roll spall occurs. Fig 7 shows that the presence of graphite in the ICDP causes deformation and cracking in connection to graphite-rich regions under loading. Graphite phase is beneficial since it may act as a solid lubricant reducing the interfacial friction force in the sliding contact (Nilsson & Olsson, 2013). EDS analysis confirmed the oxide or scale at the shell-core interface.

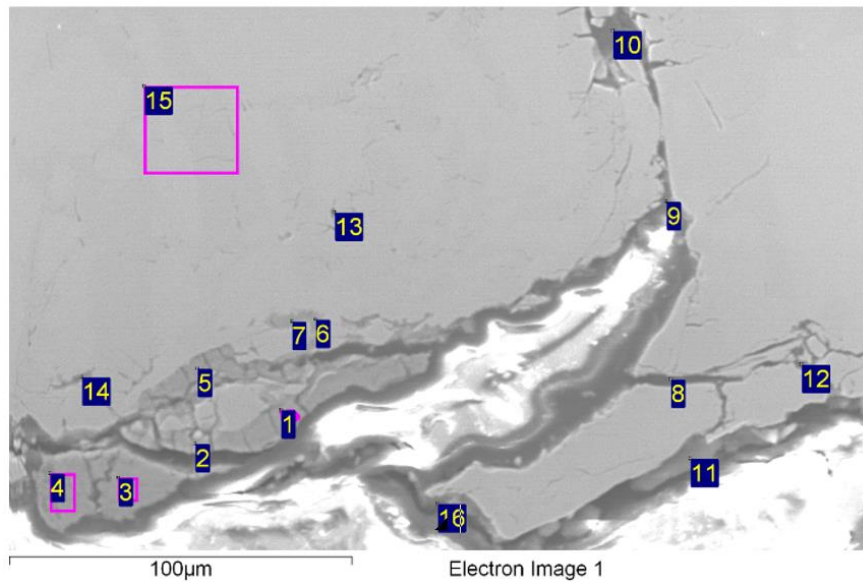
Figure 8. EDS analysis of spalled sample on the shell – core interface

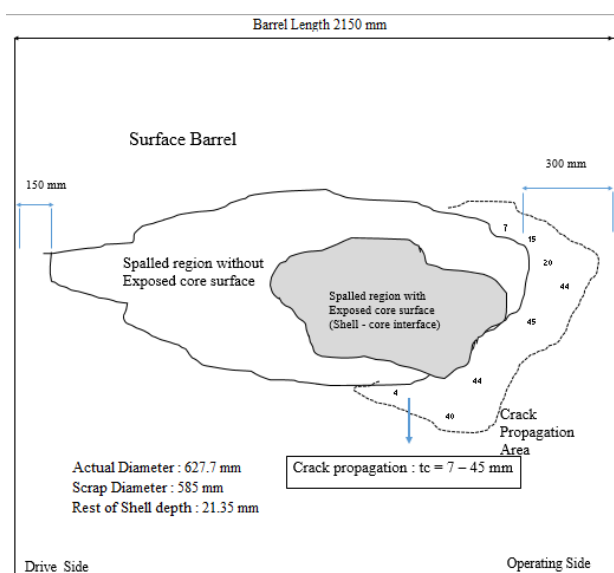
been measured using an ultrasonic test with the USKS 8S type. UT test parameters are presented in the table 4. The propagation of the crack can be seen in Figure 9. The propagation of the crack is 7-45 mm deep around the non-spalled area on the Operating Side.

Figure 9. Two-dimensional projection of ultrasonic test results on a spalled roll

Ultrasonic evaluation of the spalled roll revealed a crack propagation from the exposed spalled region at the operating side. The depth of the crack was 7-45 mm. The propagation crack may be a consequence of spalling. Cleanliness from ICDP's casting roll will significantly affect the bonding of shell and core. Some of the causes that make the shell and core bond wrong are the residual oxide layer between the shell and the core, flux or slag at the interface, excess carbide, microporosity, graphite flakes, or non-metallic inclusions such as sulfides (Roll Failures Manual Hot Mill Cast Work Rolls, 2002). Scale or oxide on the shell core interface, causing the bond between the shell and the core to be weak.
