Failure analysis on tube arm cylinder hydraulic excavator

Abstract—The Failure on tube rod arm cylinder hydraulic excavator caused to lose production and processing time on mining site. Investigation included visual inspection, chemical analysis, metallography analyzes, and microhardness test. Tube material used high silicon material type while the standard used ST52 carbon steel type. The tube was broken and crack to several pieces. The chemical composition of the tube has different in sulfur and silicon content. From hardness test with micro hardness method, sample tube broken has lower hardness compared to standard hardness. Metallography analysis obtained the phase of tube has same phase with standard which is ferrite and pearlite phase but has different grain size. Based on this study, it can be resumed failure on tube is because impurities and different specification on raw material.

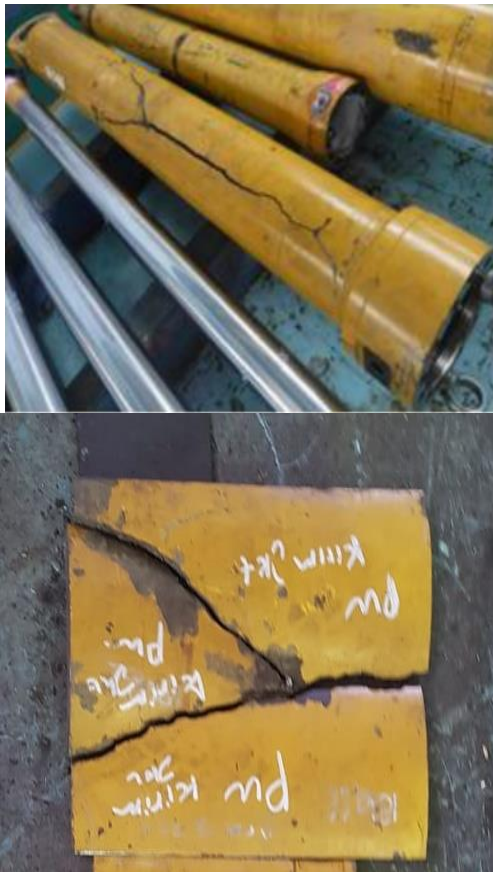
Figure 3. Broken tube sample

Figure below show broken part from the tube and it divided into several pieces. We did some test and analyze, to obtained data from piece of crack on surface and inner diameter tube.

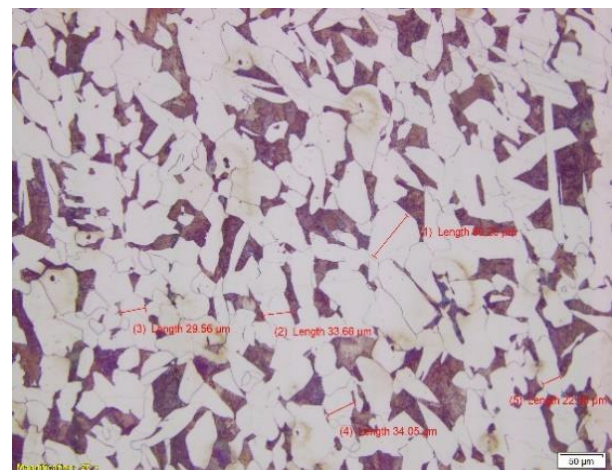
Figure 4. Broken Tube Sample Microstructure

Using an optical microscope. In this tube arm cylinder broken analysis, the thing that is of concern is the phase contained in the arm cylinder broken part. Based on the results of the microstructural analysis, the broken tube arm cylinder sample consists of ferrite and pearlite phases which have ductile and tough properties. Whereas the reference ST52 also consists of ferrite and pearlite phases which have ductile and tough properties. Based on the analysis of

ferrite grain size, it can be seen that the grain size of ferrite up to the arm cylinder sample looks larger (34-60 μm) than the grain size of Reference ST 52 ferrite, which is (26-28 μm) (Zhou et al., 2020). The larger the grain, the lower the hardness and tensile strength, but the better the ductility (Khodabakhshi & Gerlich, 2020). As explained in the Figure 6.

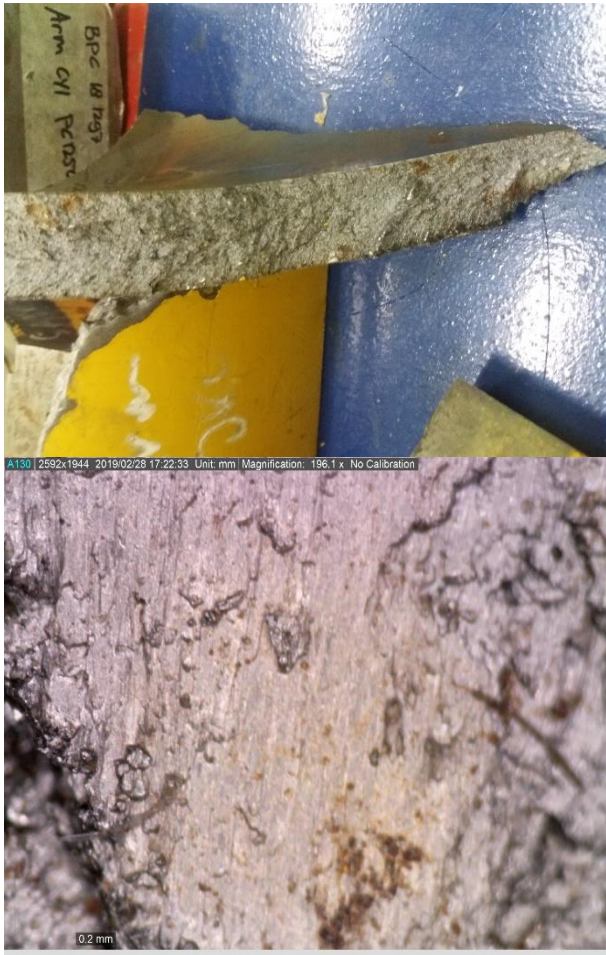
Figure 8. Surface sample fracture

With dino-lite portable microscope we examined the surface broken area, the surface has rough and smooth fracture area which indicated is spontaneous fracture. No beachmarks or striation seen, which indicated fatigue failure not the main fracture for this failure.
