## Failure analysis of ICDP work roll of hot strip mill case study of shell-core interface spalling

**Keyword:** *ICDP Work Roll, Hot Strip Mill, Shell-Core Interface, Spalling*

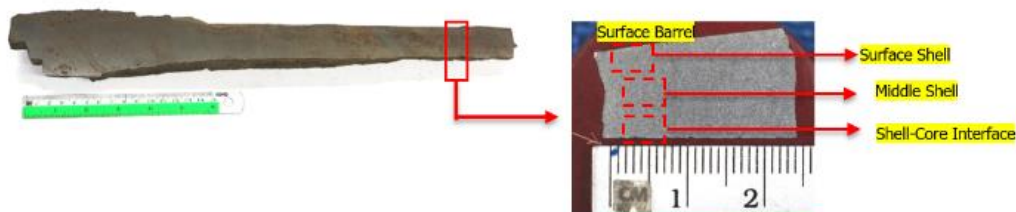
Figure 3. Specimen for cut analysis

Figure 2 shows a general view of the spalled roll. Rolls that have been spalled are subjected to a visual test to identify failure modes. Chemical composition was measured by spectrometer. A specimen from the roll spall was cut for metallography analysis, as shown in Figure 3. The specimens were mounted with resin and then ground using a grinding machine and polished to 3 microns using standard metallographic techniques. The polished specimens were etched with 2% Nital solution to reveal the microstructures.
