Failure analysis on tube arm cylinder hydraulic excavator

Abstract—The Failure on tube rod arm cylinder hydraulic excavator caused to lose production and processing time on mining site. Investigation included visual inspection, chemical analysis, metallography analyzes, and microhardness test. Tube material used high silicon material type while the standard used ST52 carbon steel type. The tube was broken and crack to several pieces. The chemical composition of the tube has different in sulfur and silicon content. From hardness test with micro hardness method, sample tube broken has lower hardness compared to standard hardness. Metallography analysis obtained the phase of tube has same phase with standard which is ferrite and pearlite phase but has different grain size. Based on this study, it can be resumed failure on tube is because impurities and different specification on raw material.

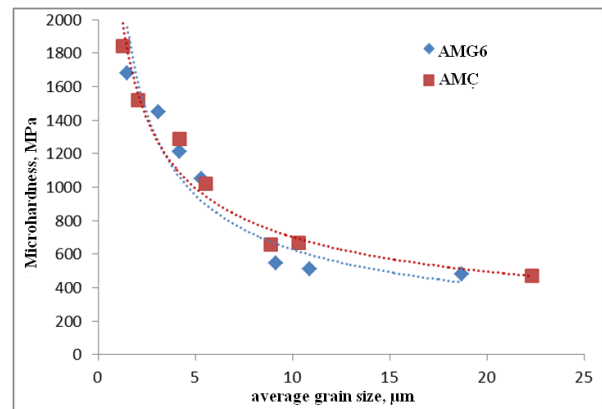
Figure 6. Correlation Hardness and Grain Size

ferrite grain size, it can be seen that the grain size of ferrite up to the arm cylinder sample looks larger (34-60 μm) than the grain size of Reference ST 52 ferrite, which is (26-28 μm) (Zhou et al., 2020). The larger the grain, the lower the hardness and tensile strength, but the better the ductility (Khodabakhshi & Gerlich, 2020). As explained in the Figure 6.

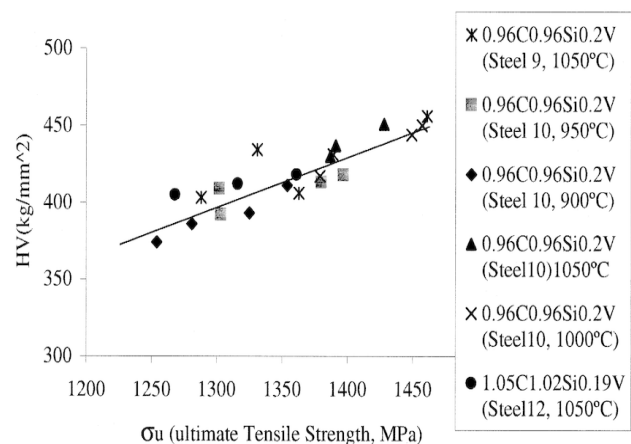
Figure 7. Correlation hardness and tensile strength

Based on the hardness test with a microhardness tool, it can be concluded that the hardness of the tube arm cylinder part material is 178.06 HV (below 10 HRC) and on the ST 52 reference tube is 222.74 (19.54 HRC). So based on the microhardness test, it can be seen that there is a hardness difference of around 10 HRC between the arm cylinder and the reference ST52. This can reduce the strength of the tube cylinder and be a starting point for fracture and failure. And according to the initial hypothesis in the microstructural analysis, the larger the grain size, the lower the hardness (Wang et al., 2021). Pressure was happened in tube cylinder is internal pressure from oil and external pressure from the mounting on hydraulic excavator.
