## Harmonic Distortion Characteristics Generated by Heating Ventilation Air Conditioning System Case Study in PCR Laboratory

Reza Andika Setyadi<sup>1\*</sup>, Rudy Setiabudy<sup>2</sup>

<sup>1,2</sup>Electrical Engineering, Faculty of Engineering, Universitas Indonesia, Depok 16424, Indonesia

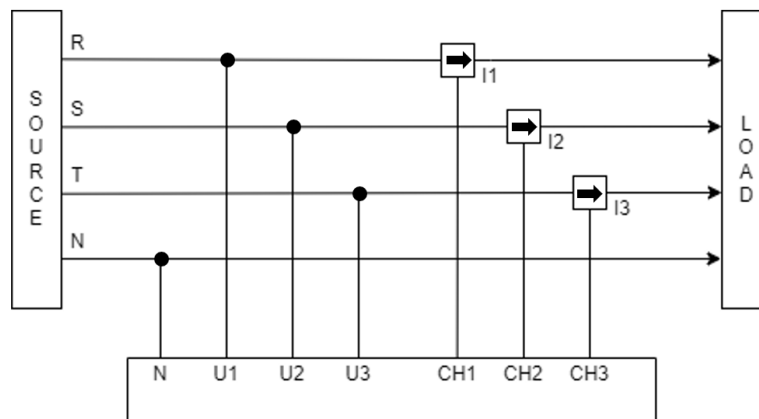
Figure 2.a. Measurement wiring setup diagram

Figure 2 shows the PQA wiring setup at the HVAC Panel. After the wiring has been connected according to Figure 2.a. then you can look at the PQA to check the measuring cable connection. After all parameters of the measuring cable connection have been read as "ok" on the PQA, the measurement can be started, in this measurement the PQA is set to start the measurement manually and stop automatically.

In this study a power quality analyzer brand H equipped with 4 voltage clamps & 3 amperage clamps is used to measure and record data of power quality including harmonics. Figure 2 shows the wiring scheme from the measuring device to the electrical installation of the HVAC panel. Measurements were carried out for 4 days non-stop using a power quality analyzer at the HVAC panel of the PCR Laboratory.

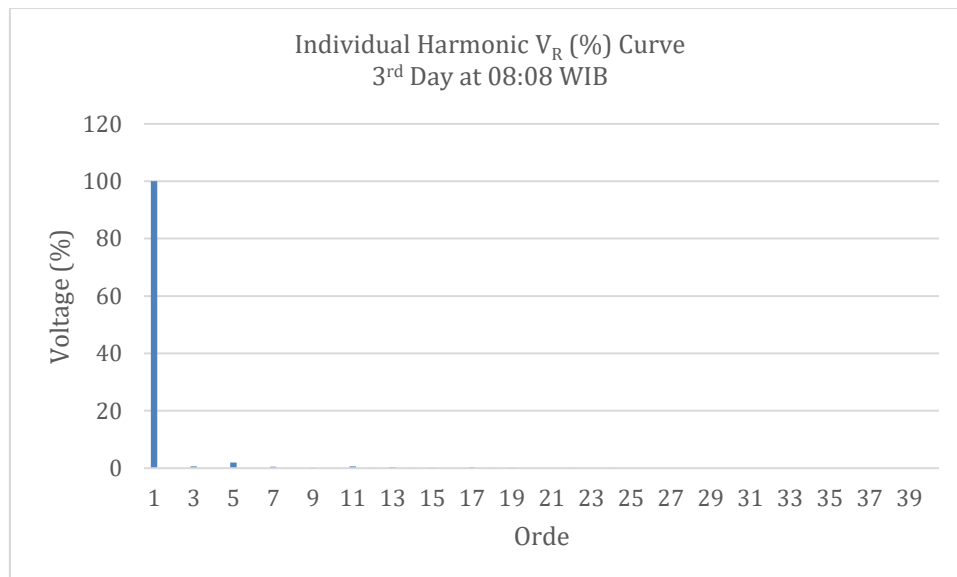
Figure 3 shows the curves of individual Phase R voltage harmonics on 3<sup>rd</sup> day at 08:08 WIB which was recorded as having the highest THD<sub>V</sub> value. It can be seen that no individual harmonics exceed the 5% limit value as required in IEEE std 519-2022.

Figure 3. Individual Voltage<sub>R</sub> Harmonic (%) Measurement Curve on 3<sup>rd</sup> at 08:08 WIB

From the results of the research that has been done, no significant total harmonic distortion and voltage harmonics were found, with a maximum THDv value of 2.3% and individual voltage harmonics ( $h \leq 50$ ) of 1.99%, still below the standard required by IEEE Std 519-2022 of 5% for individual harmonic voltages and 8% for total harmonic distortion. While the current value obtained by the maximum TDD is 10.41% and the maximum individual harmonics is 97.48% (at order 5). The TDD value is still below the standard required by IEEE Std 519-2022 of 15%, but for individual harmonic values the current exceeded the required limit of 12% (for order  $2 \leq h < 11$ ).

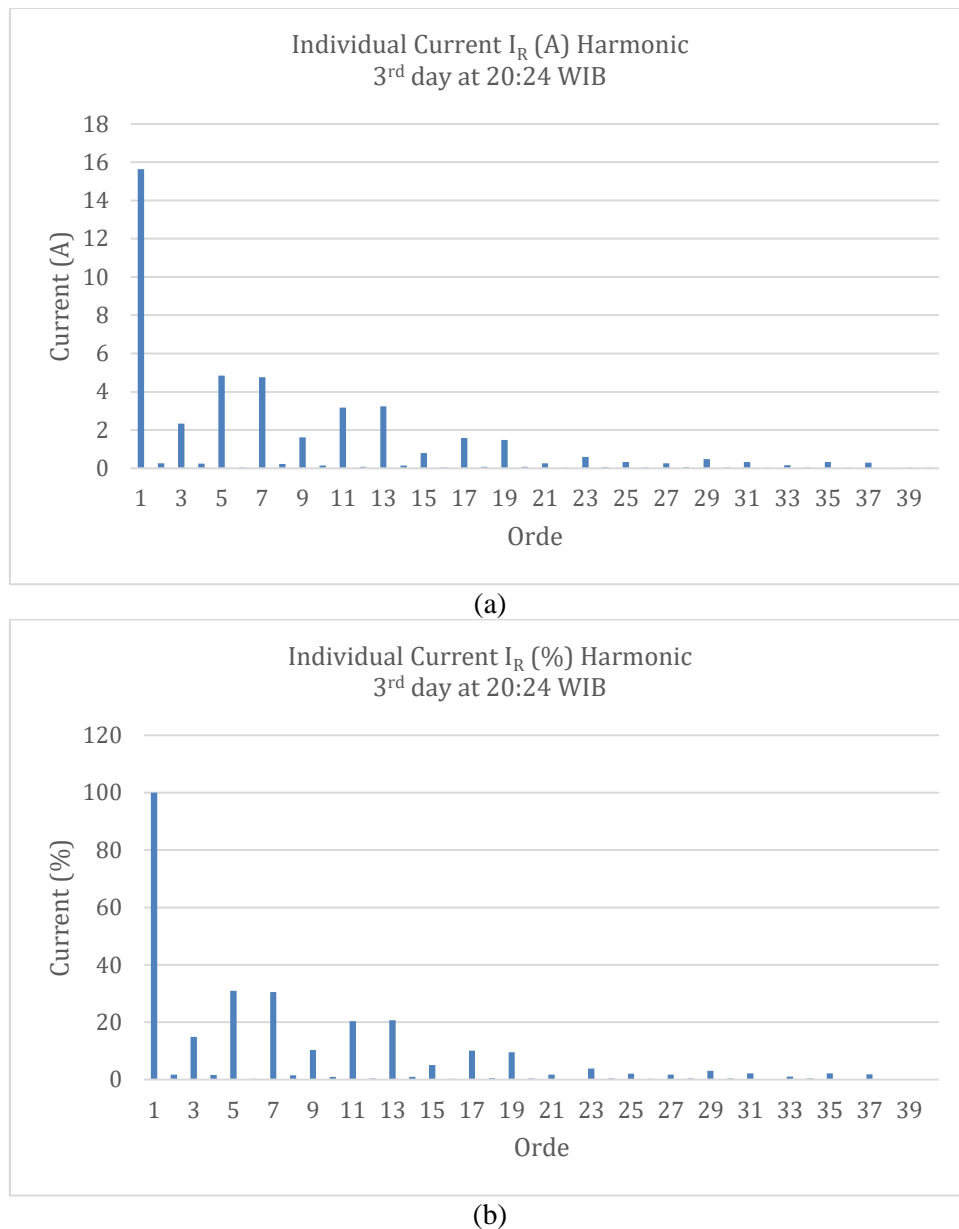
However, the individual current harmonic values shown in Figure 4 that only odd order multiples of 3 (except order 3) have individual current harmonic values below IEEE std 519-2022 considering that a 3-phase system does not generate triplen harmonics.

Figure 4. Individual Current ( $I_R$ ) Harmonics Measurement Curve on 3<sup>rd</sup> day at 20:24 WIB: (a). Current (A); (b). Current (%)

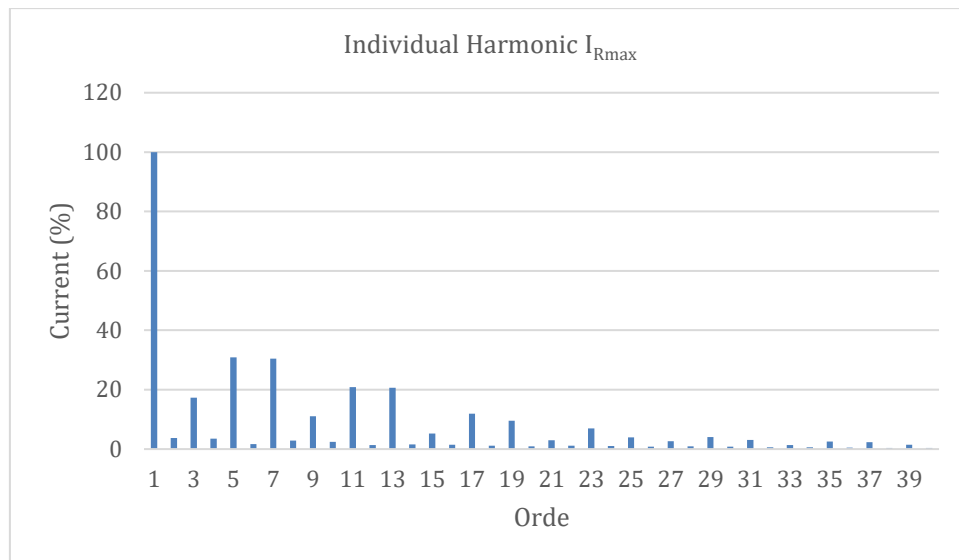
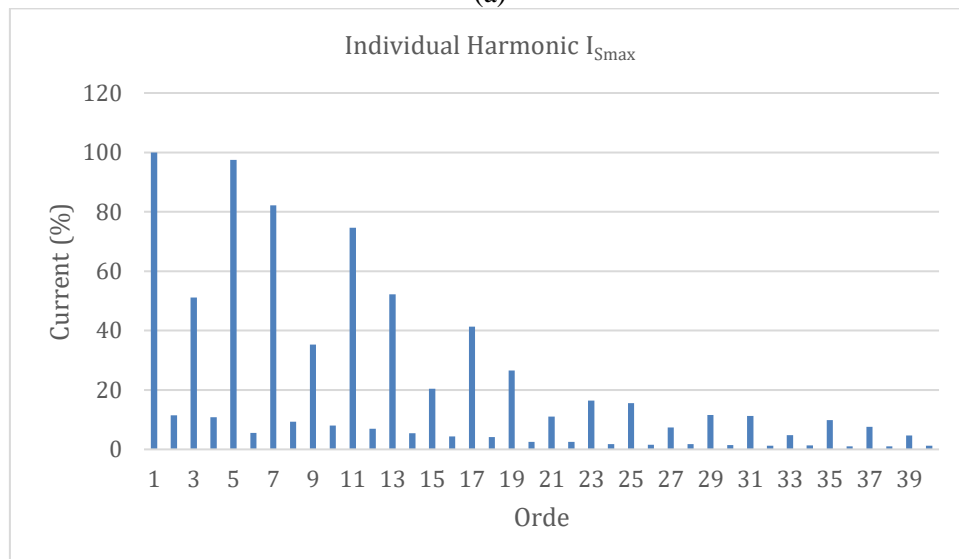
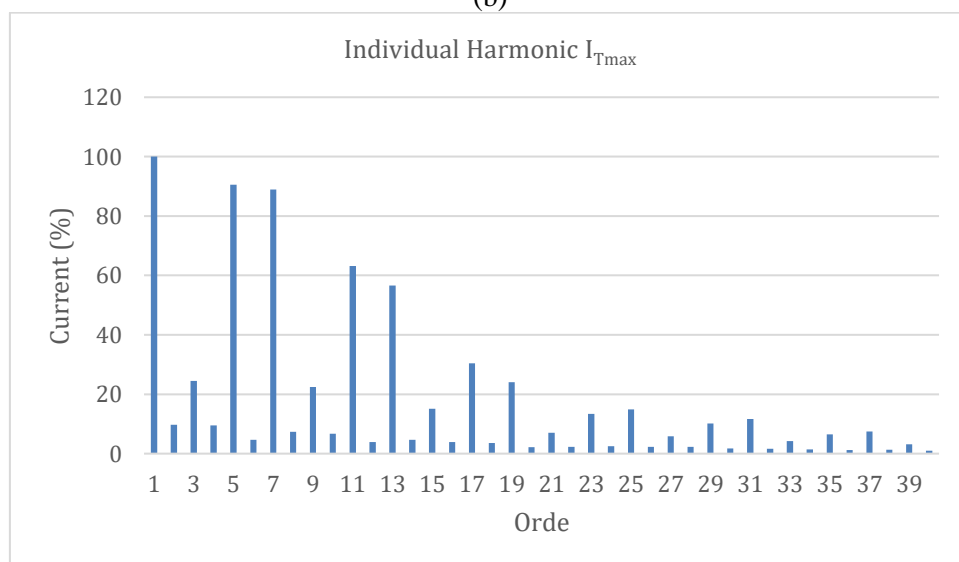
We process the data obtained by the measurements to find the maximum individual harmonic values for each order and phase as shown in Figure 5 below. It can be seen that the current containing harmonics are dominant in odd orders except for multiples of 3.

Figure 4. Individual Current Harmonic (Maximum): (a).  $I_R$  (%); (b).  $I_S$  (%); (c).  $I_T$  (%)

Based on the measurement, processing, and analysis of the data, it can be concluded that the use of a non-linear load in this case the VFD on the AHU unit in the PCR Laboratory Clinic A generates harmonic distortion in the current. This distorted current has harmonic content in odd orders other than multiples of 3 with the 5<sup>th</sup>, 7<sup>th</sup>, 11<sup>th</sup>, and 13<sup>th</sup> orders which are quite dominant.
